HATCHIE

BIG LAKE DAM
INSPECTION REPORT

BIG LAKE DAM
ON A TRIBUTARY OF HATCHIE CREEK
A TRIBUTARY OF THE MISSISSIPPI RIVER
HAYWOOD COUNTY
TENNESSEE

FEDERAL INVENTORY NUMBER TN 07505

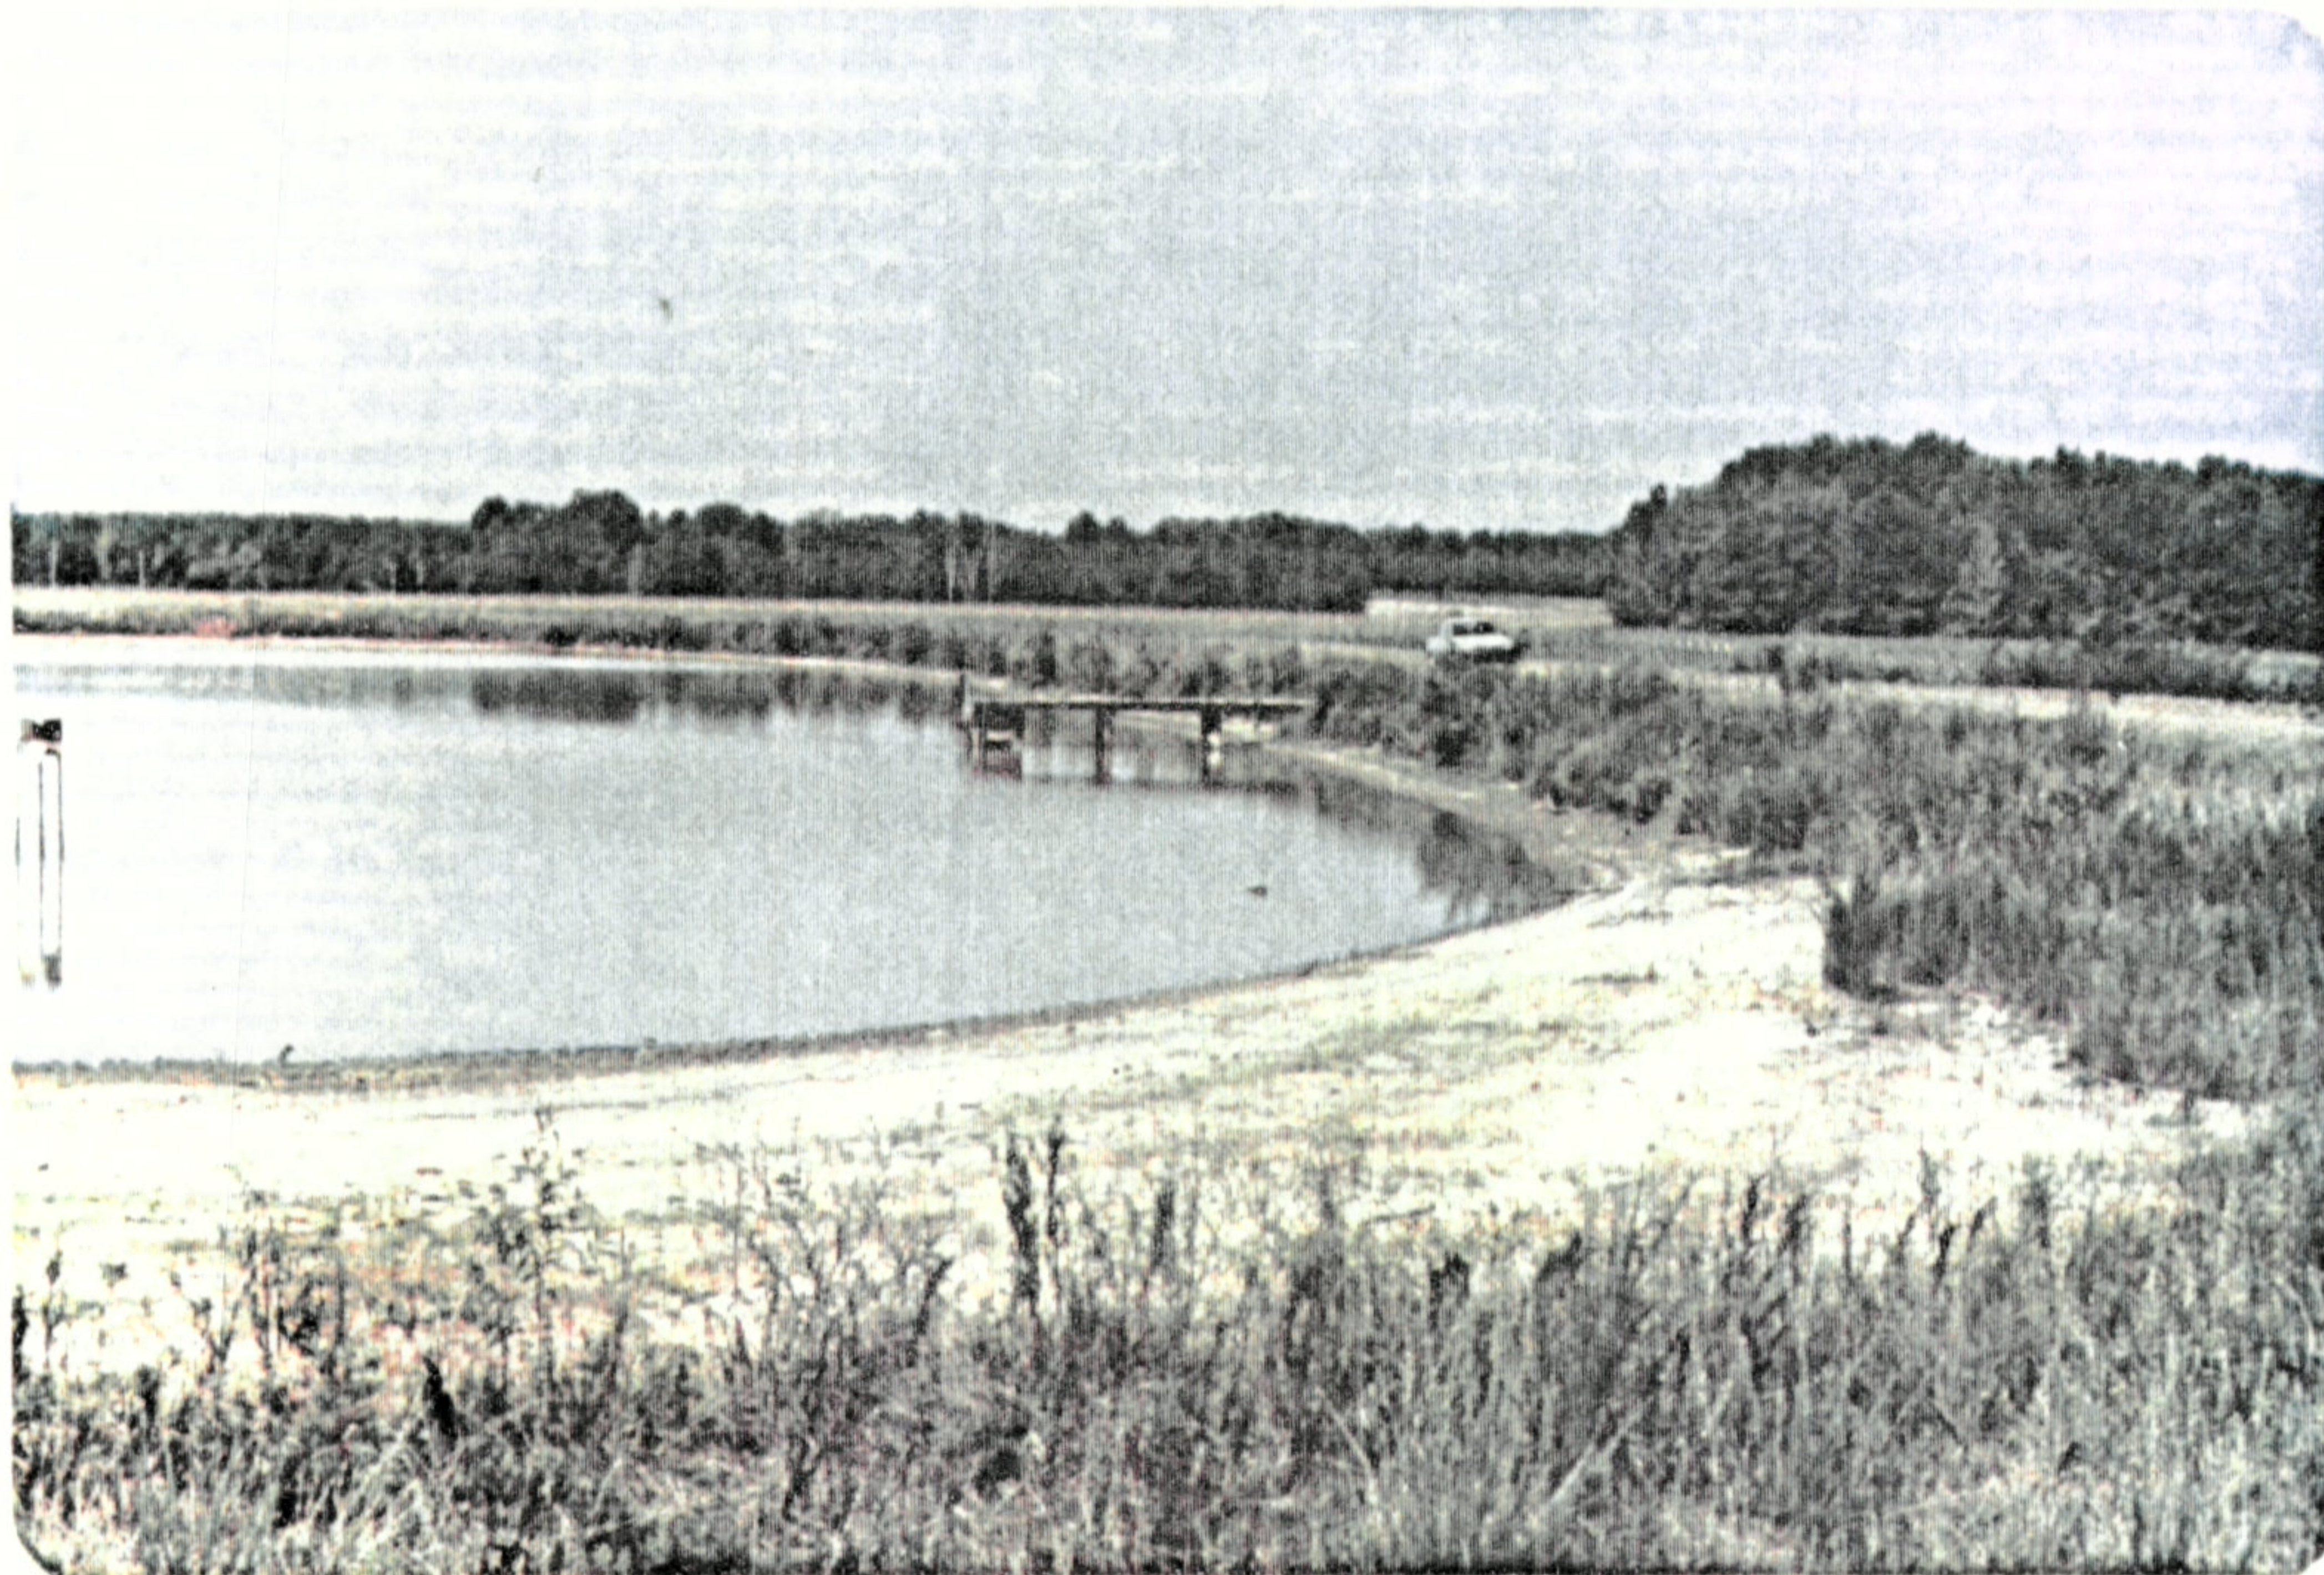
- a. Upstream Face. The slope was only visible above the water surface which was approximately 1 foot below the normal pool level at the time of the inspection. The slope, above normal pool, is protected with a vegetative cover. Bushes growing along normal water line. There are no visible cracks or other evidence of slope instability. See Photos Number 1 and 2.
- b. Downstream Face. The slope is protected with a vegetative cover and shows no signs of erosion. A number of trees are located on the downstream slope near the outlet pipe. There are no visible cracks or other evidence of slope instability. There is no evidence of any burrowing in the embankment.

1. UPSTREAM SLOPE AND OUTLET WORKS LOOKING WEST

2.4 Conclusions and Recommendations. The structure appears to be in good operating condition, but does show the lack of maintenance. The trees growing along the downstream slope should be removed. The bushes along the water surface adjacent to the upstream slope should be removed.

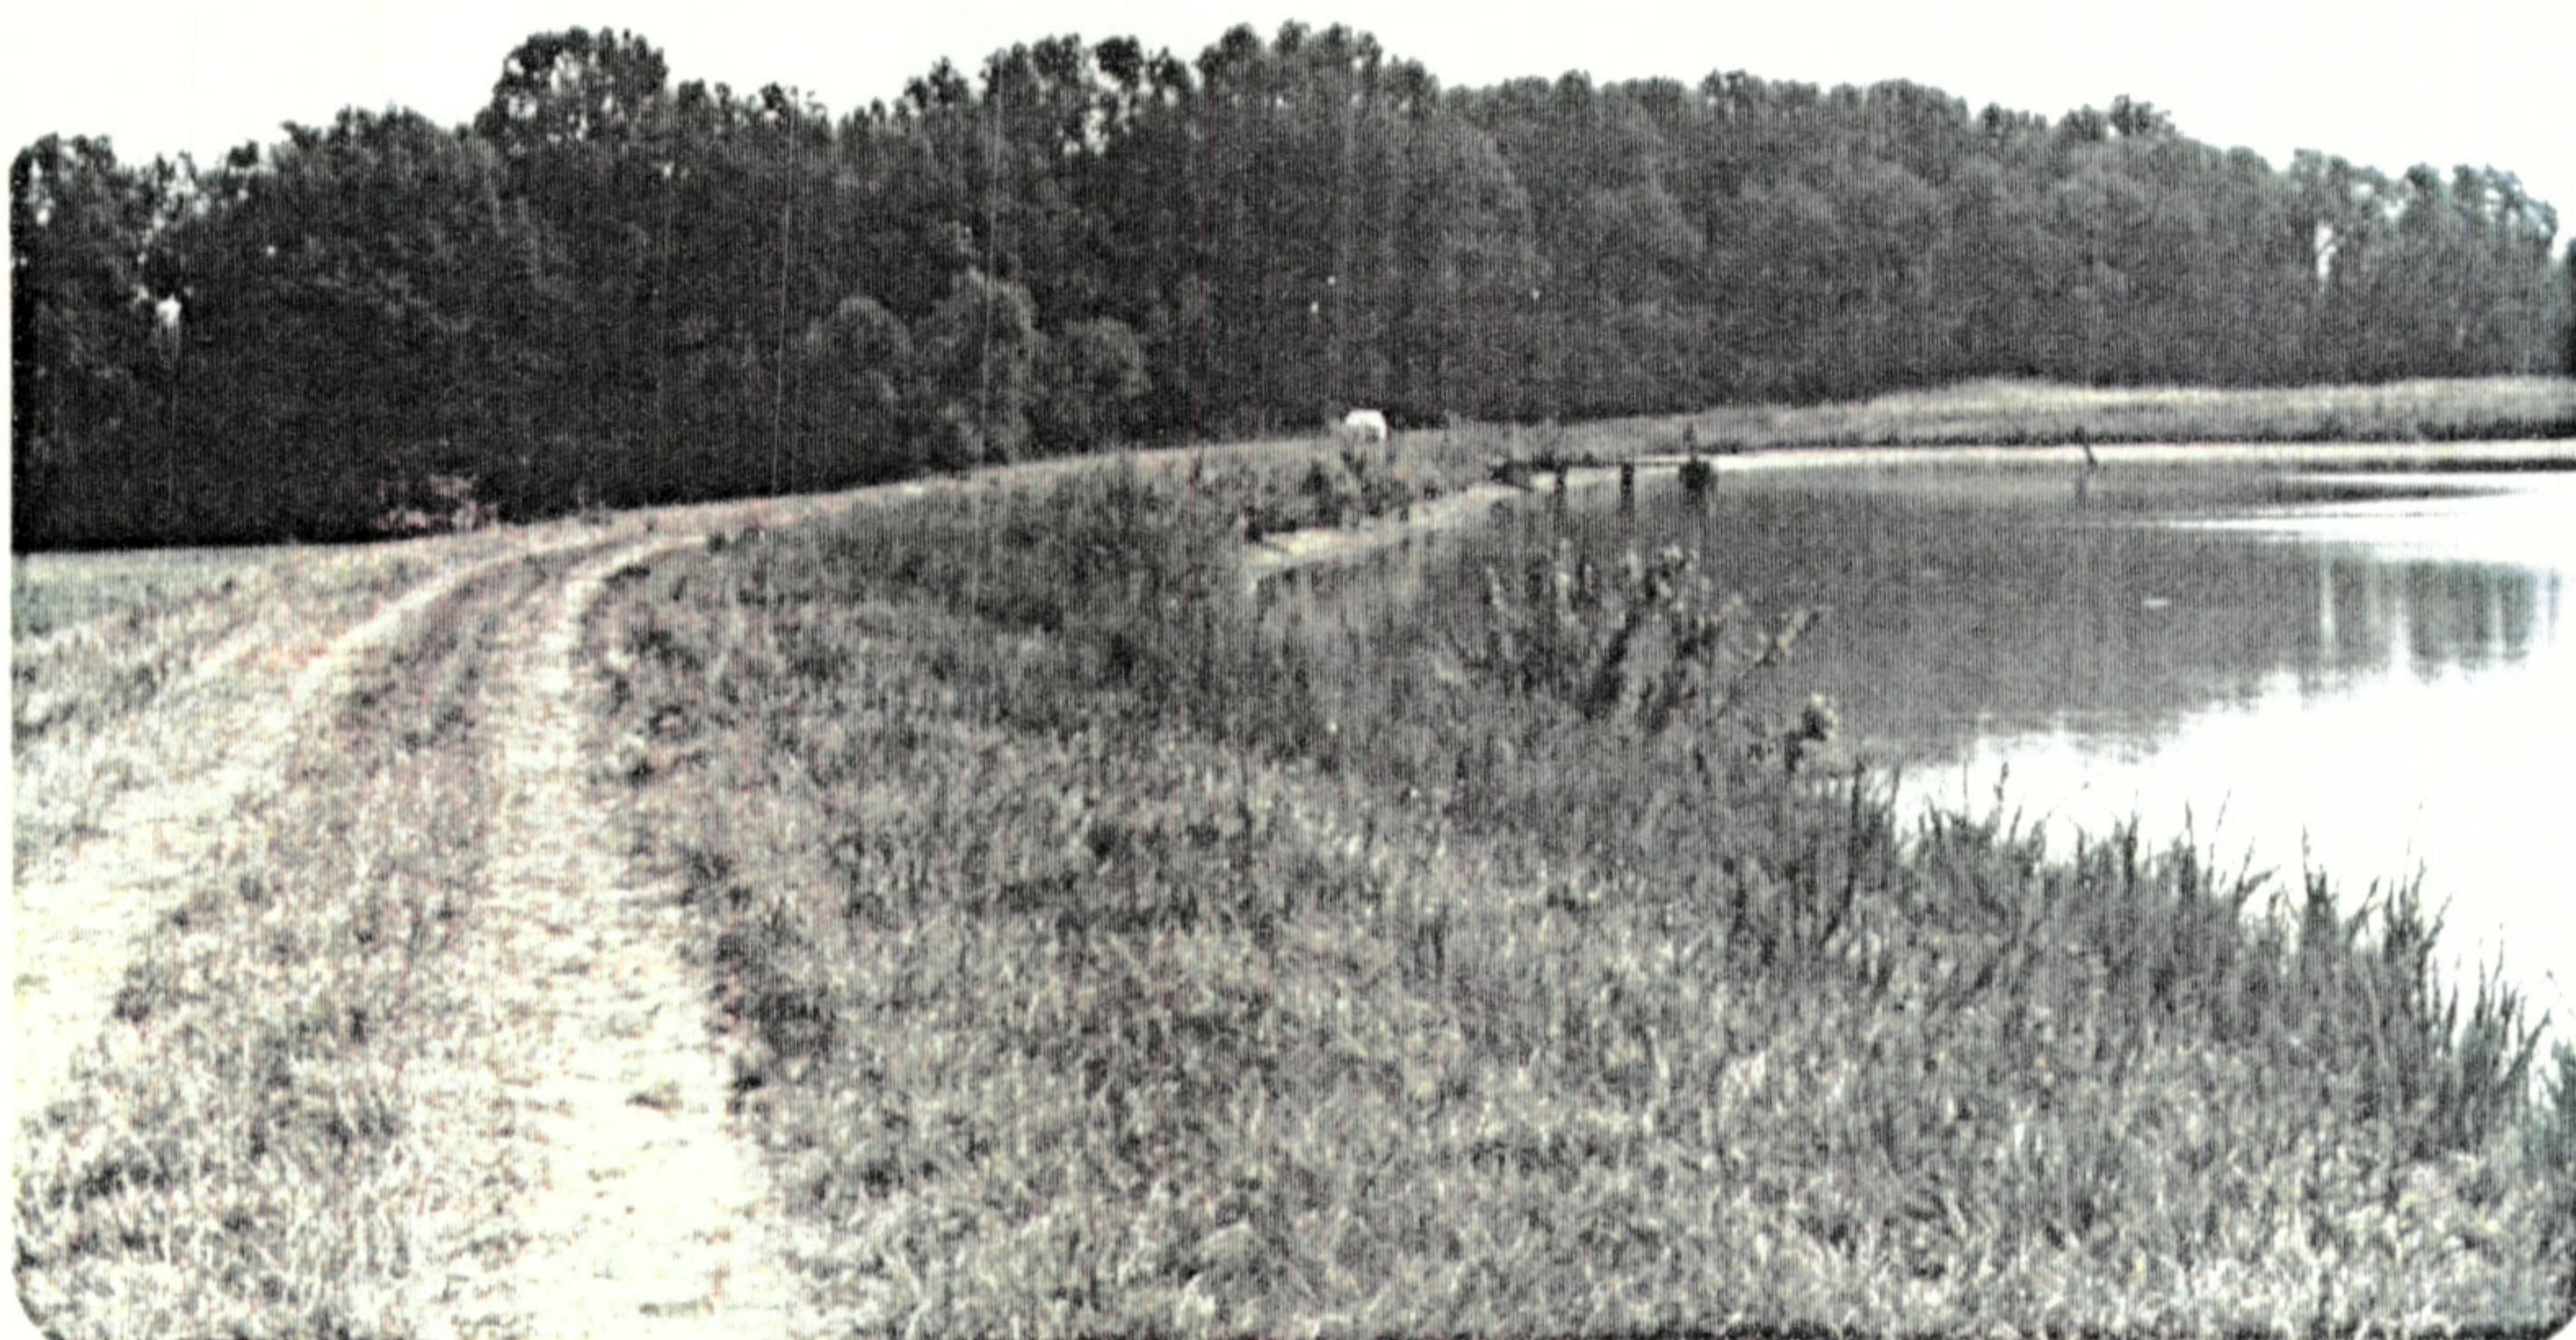
- c. Crest. The crest has a width of 16 feet and the crest elevation varies 1.5 feet from the right to left abutments. The top of the dam is used as a surfaced refuse road and the change in road grade causes the variation in the crest elevation of the dam. There are no visible cracks or other evidence of structural instability. See Photo Numbers 2 and 8.
- d. Drainage or Seepage Control. There is no drainage or seepage control in this structure.
- e. Instrumentation. There is no instrumentation in this structure.

2. VIEW EAST OR UPSTREAM SLOPE CREST

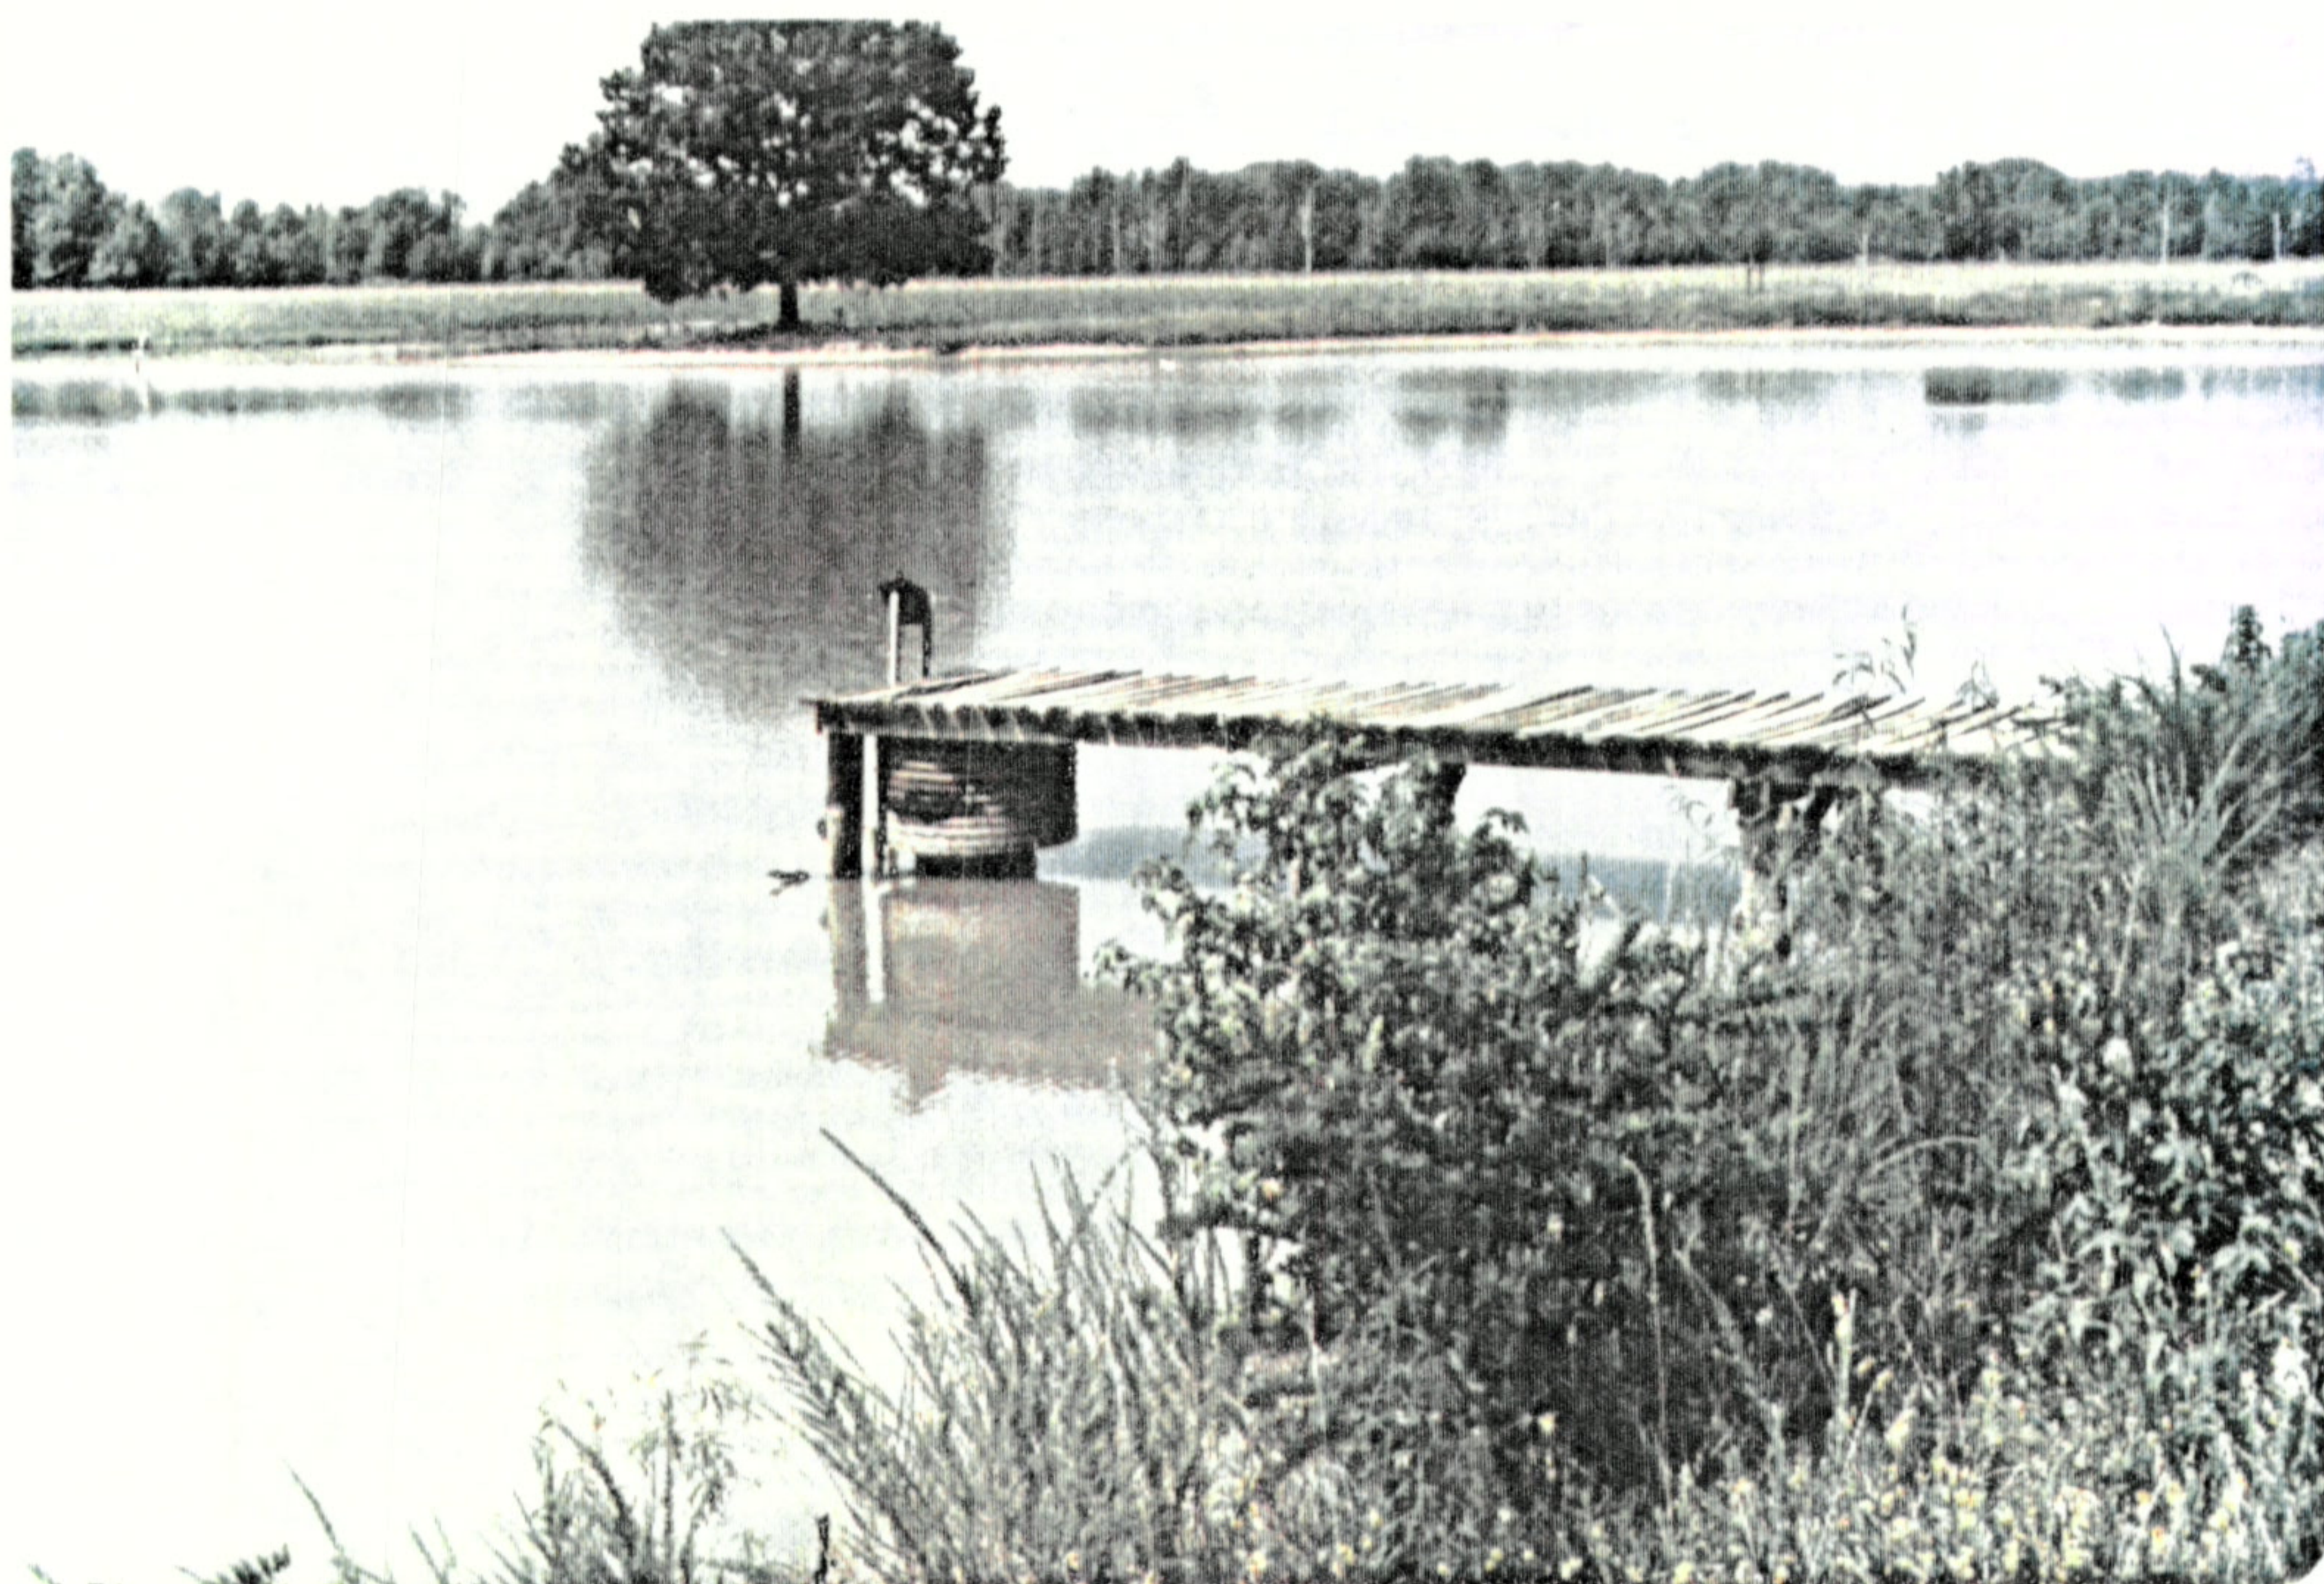
4.1 Description. The outlet is the same structure as the low level spillway. The maximum outlet capacity is approximately 10 cfs. See Photos Numbers 3, 4, 5, 6 and 7.

3. OUTLET STRUCTURE LOOKING WEST

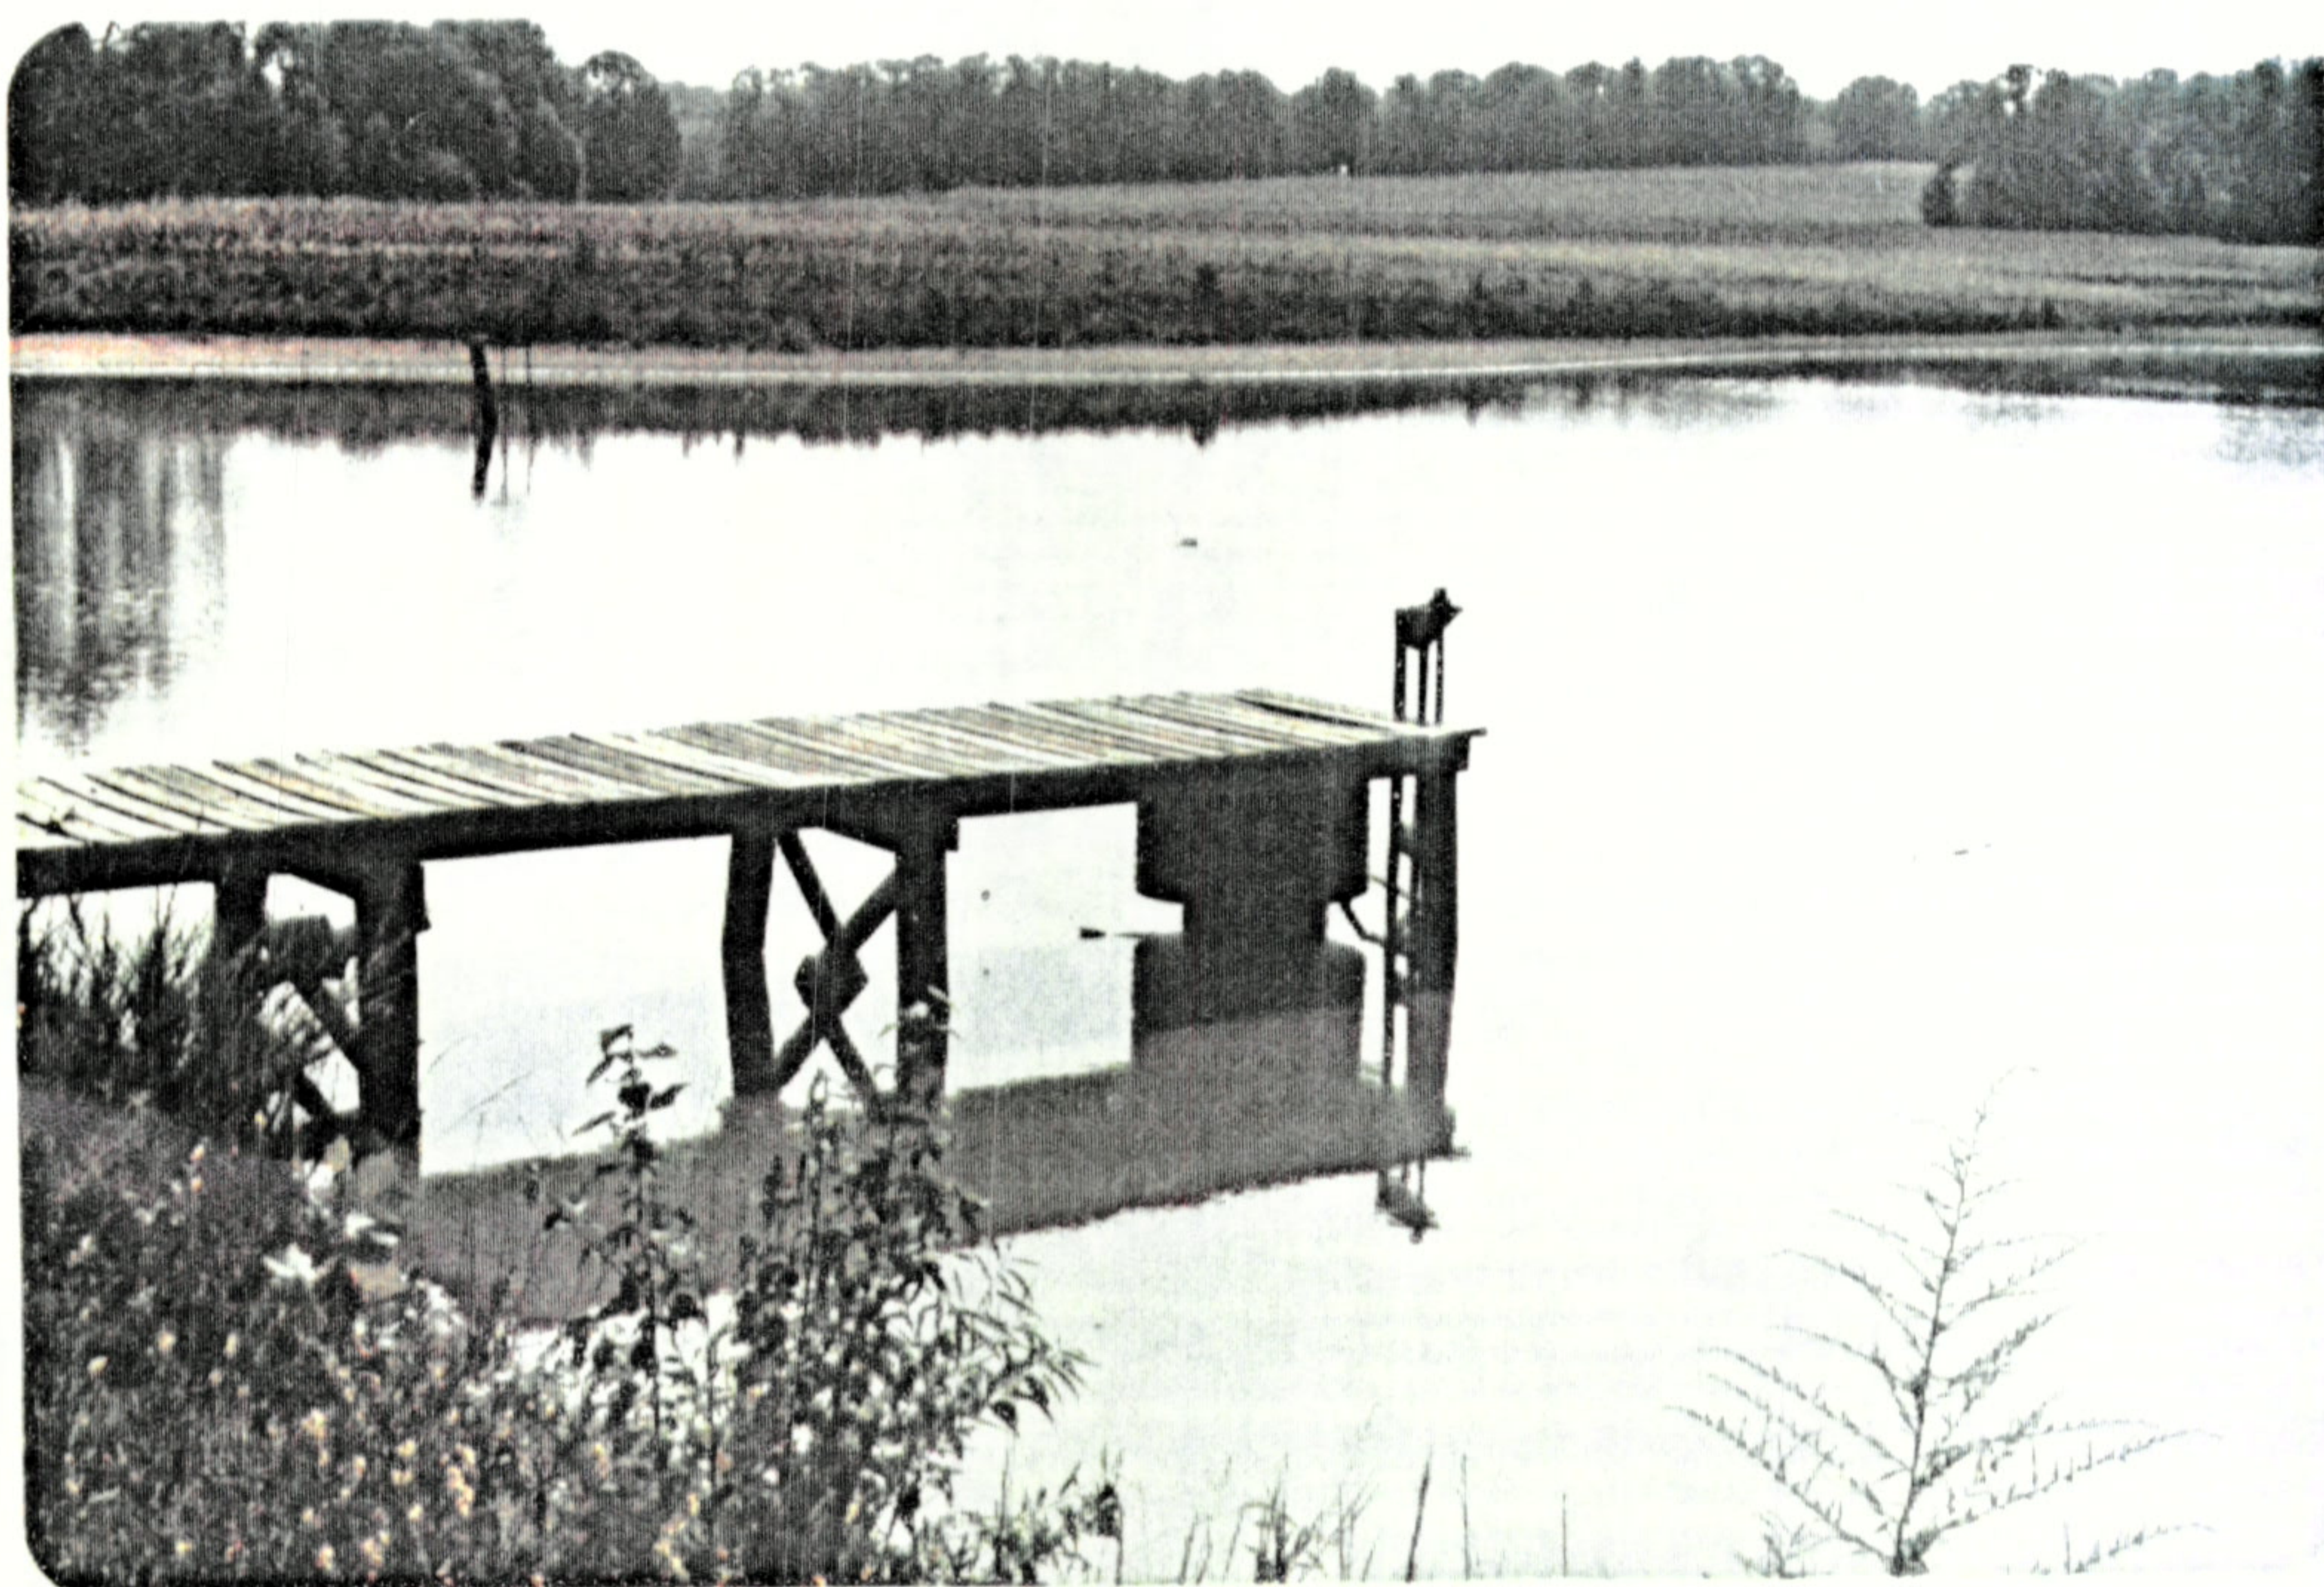
4. OUTLET WORKS LOOKING EAST

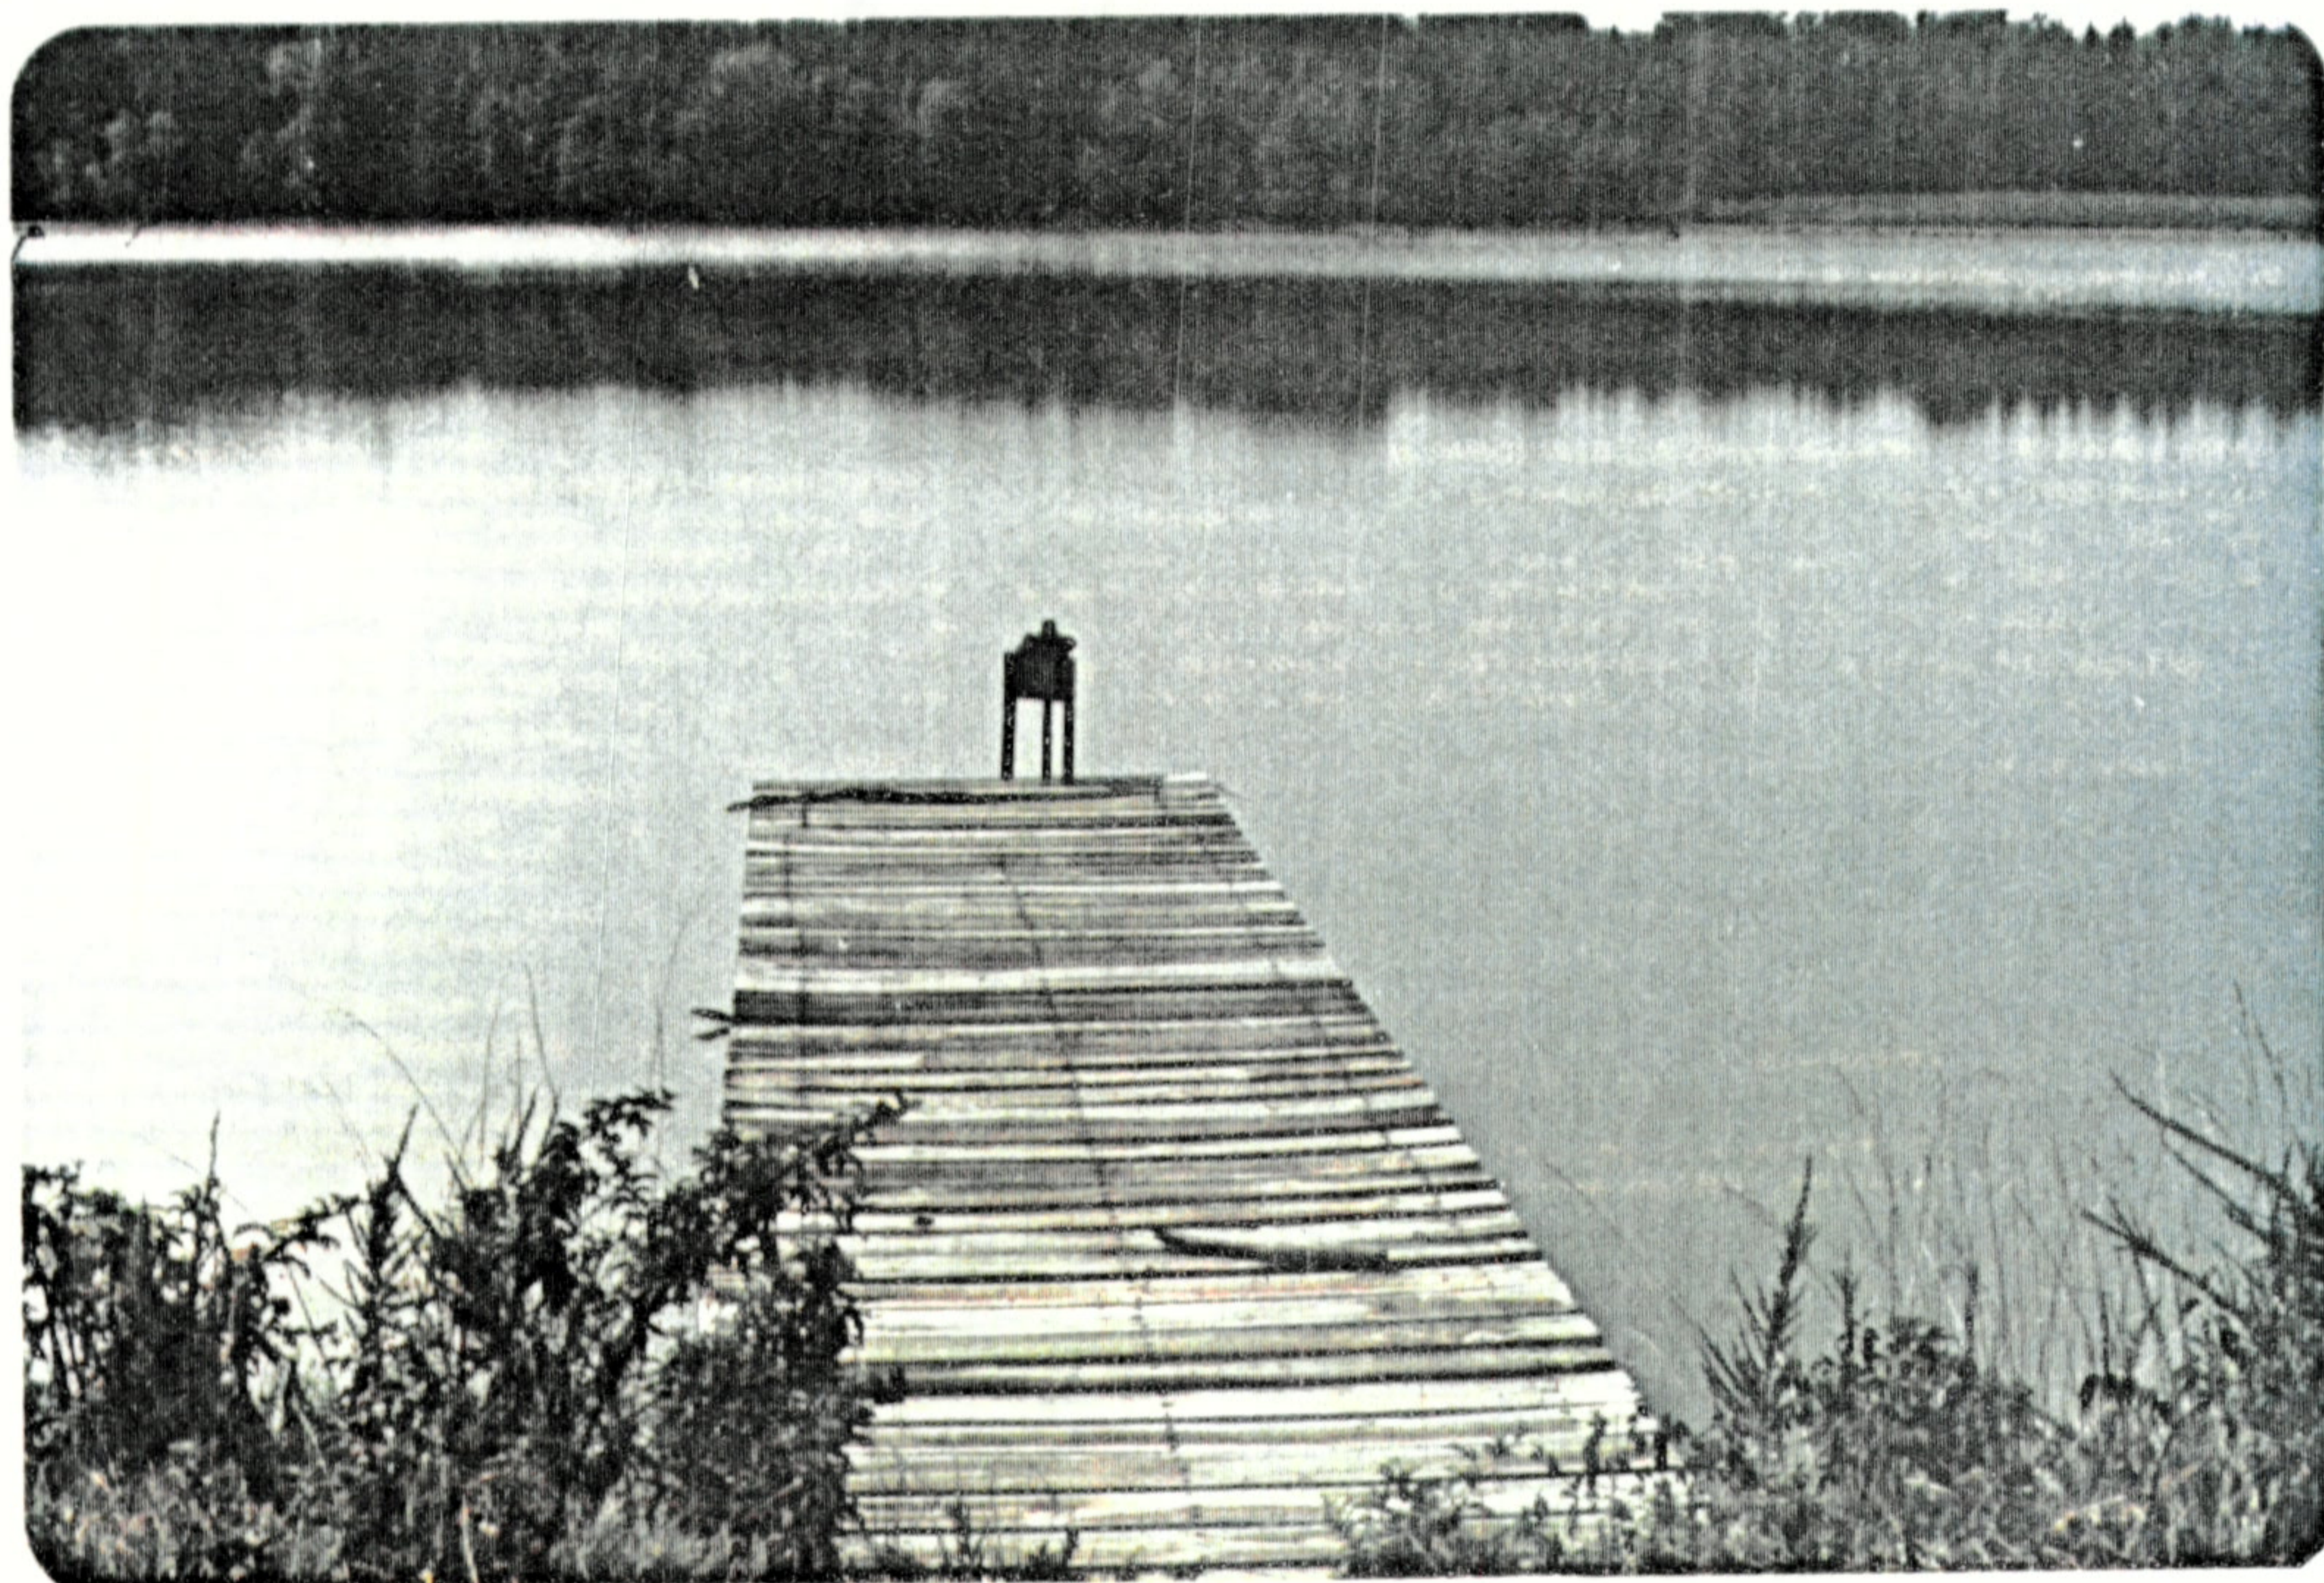
5. IMPOUNDMENT AREA

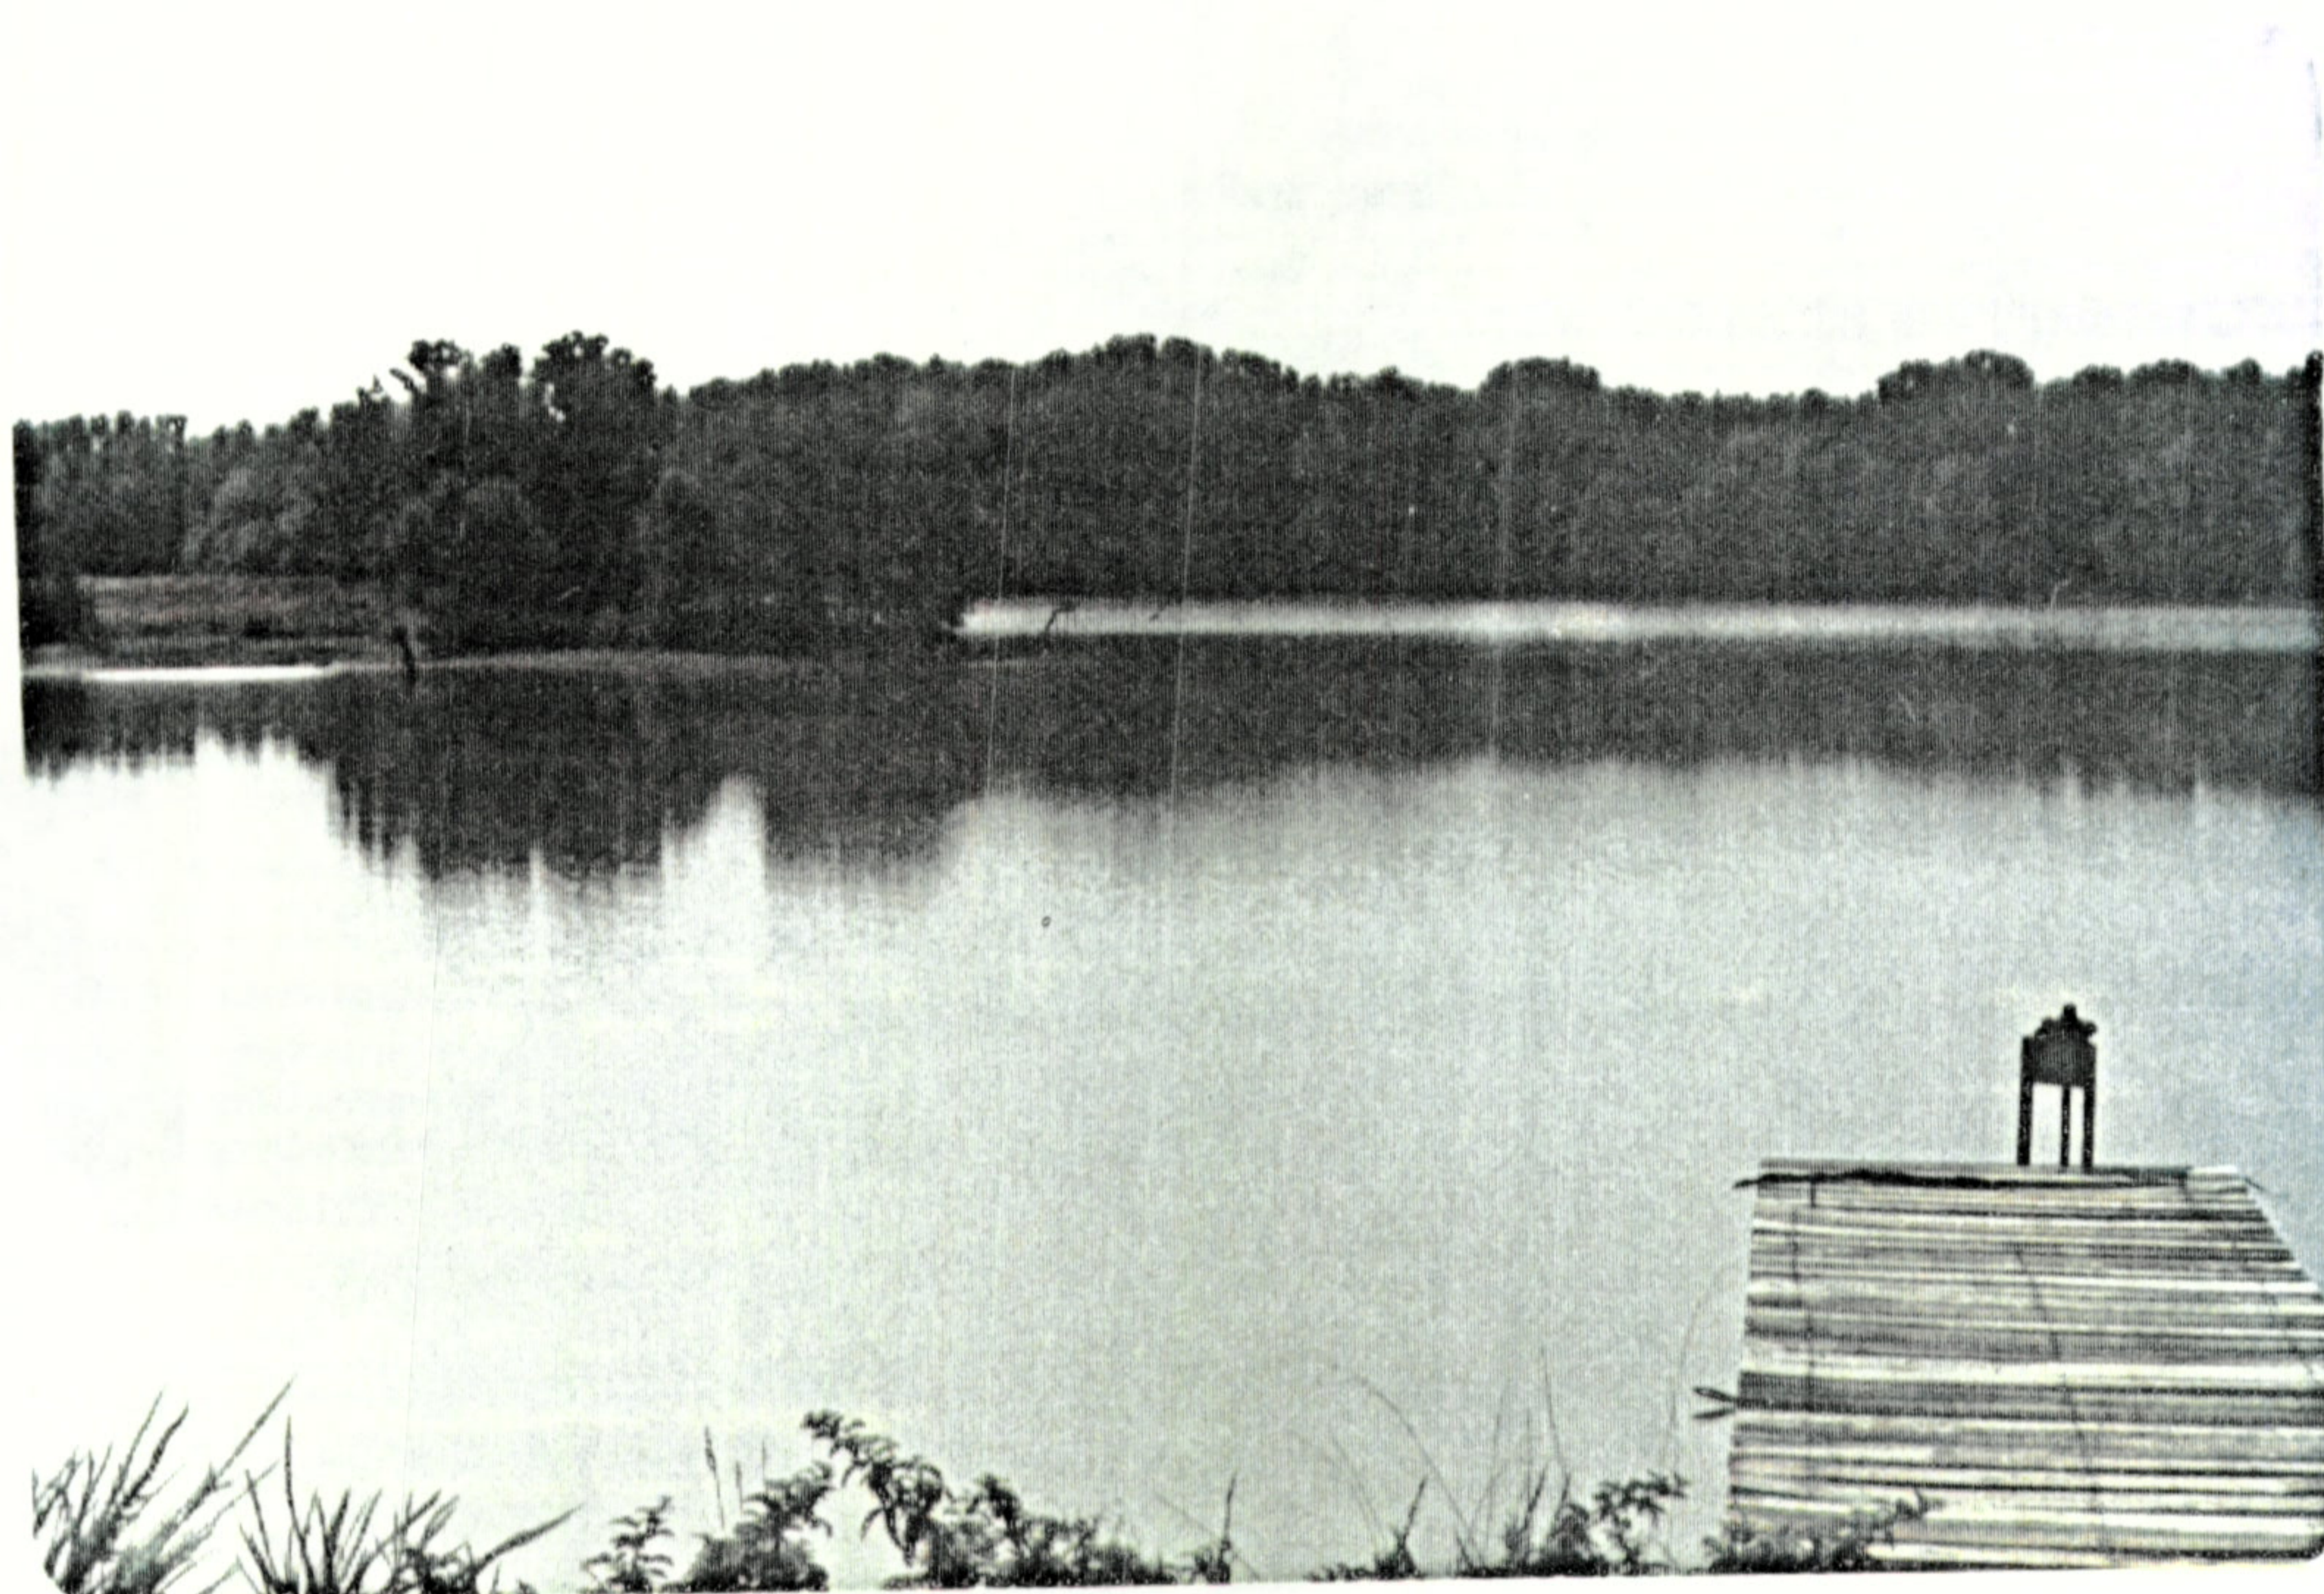
6. IMPOUNDMENT AREA
